## Lee's Branch Streambank Stabilization Midway, KY December, 2004

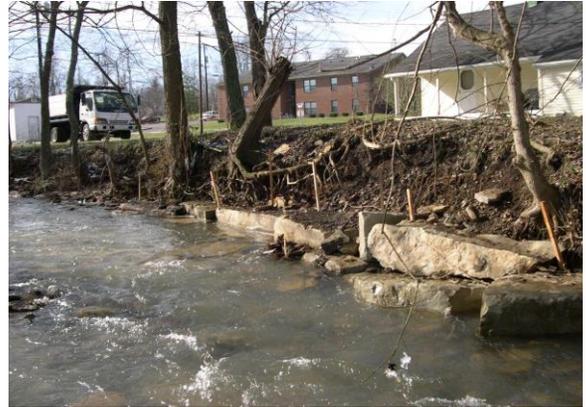
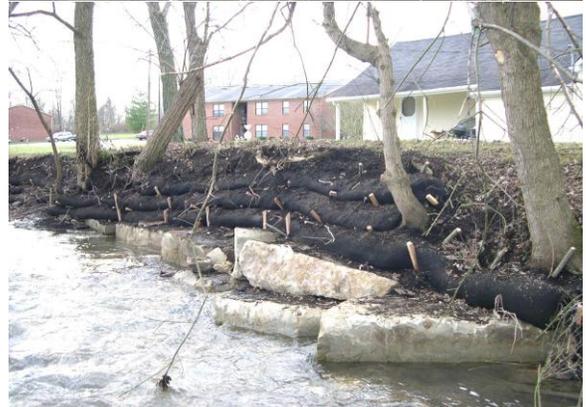
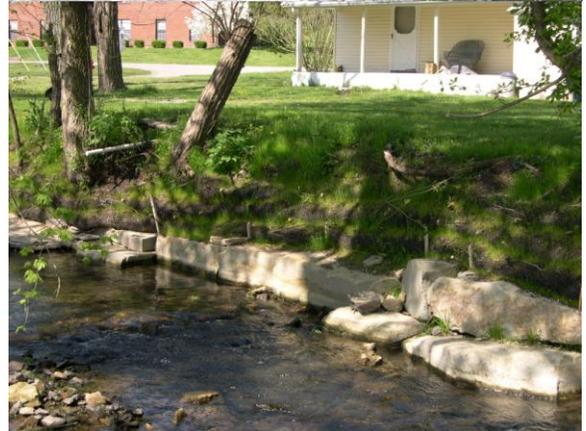
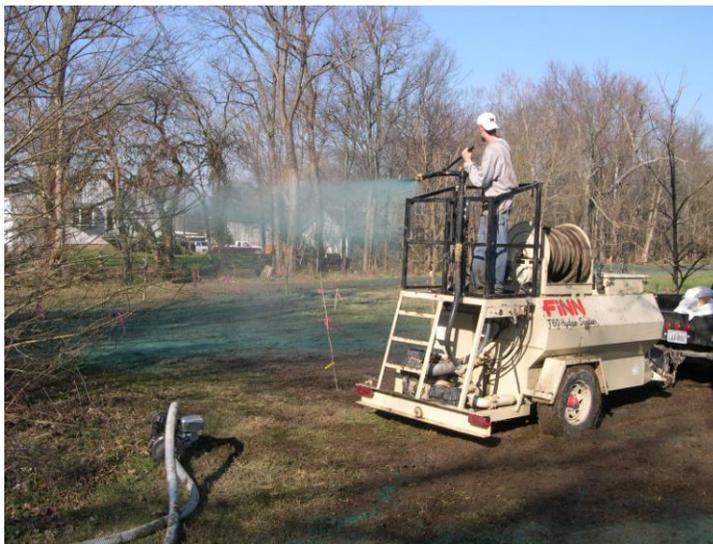
During the construction process, a rock toe was installed along 400 feet of an eroded streambank. However, due to site limitations, the designers also needed a product to stabilize the steep, bare slope without removing existing trees. A compost-based "Living Wall" application was selected to establish vegetation and stabilize the slope. EcoGro created the bioengineered onsite with the use of specialized blower trucks to pneumatically deliver a blend of compost, gravel and seed into 12" HDPE mesh tubes. Upon completion of the "Living Wall", 200 dormant willow stakes were planted along the bottom of the slope to quickly root and establish a strong, environmentally sensitive solution.

Seeding and stabilizing soil along creeks in winter can be a tricky proposition. For this project, a durable Bonded Fiber Matrix (BFM) hydromulch was applied to bind the soil within the floodplain and reduce loss of both soil and expensive riparian seed.
