Kentucky Horse Park Stormwater BMPs
Kentucky Horse Park Foundation
Lexington, KY
Project Date: August - November, 2013

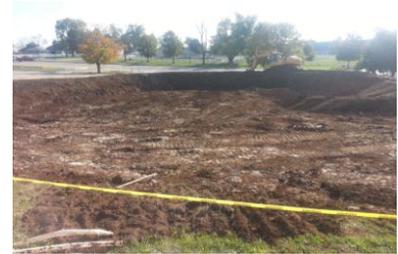
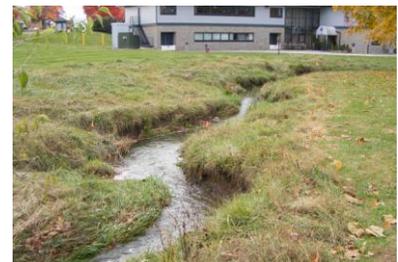
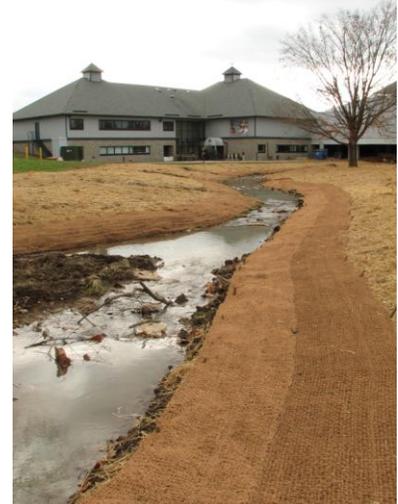
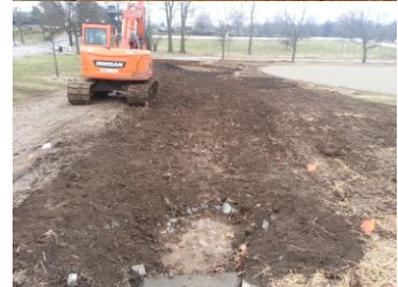
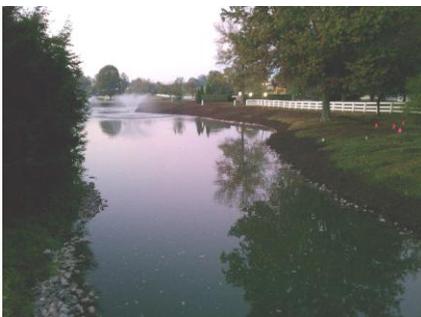
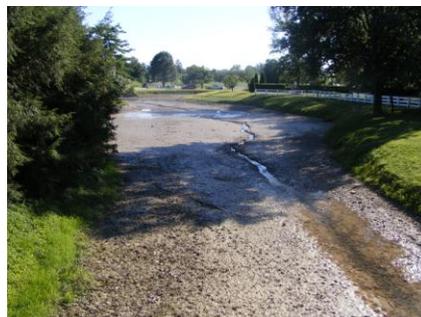
Photos (clockwise): Construction of new bioretention basin, unstable stream bank (before), graded stream bank (after), bioswale repair, pond before dredging, pond after dredging.

- Construction of a 150,000 gallon bioretention basin.
- 1,000 linear feet of stream enhancement, bank grading and riparian buffer planting.
- Dredged 5,000 cubic yards of sediment from the main entrance pond.
- Amended soil and repaired drainage system along 75 linear feet of bioswale and rain garden.
- Stabilized a channel headcut with rock and created 1,200 square feet of amended bioswale.
