West Milton Dam Removal and Stillwater River Restoration West Milton, OH October, 2014 - Spring, 2015

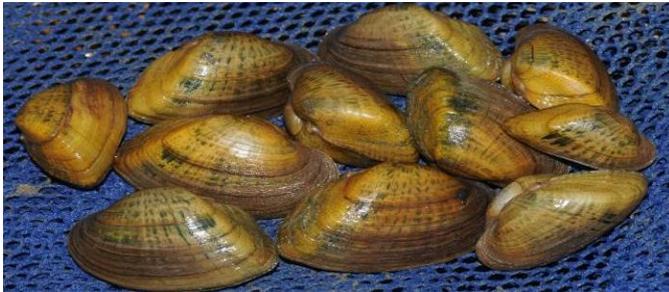
Endangered species (Snuffbox mussel) relocated by Stantec and USFWS Biologists along with Ohio River Foundation and community volunteers prior to construction.

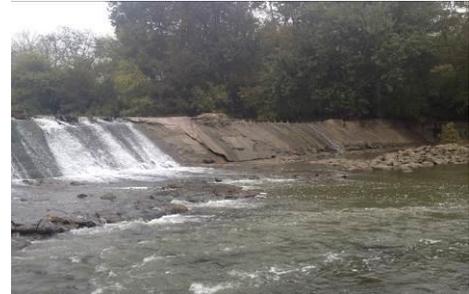
Deteriorating dam before removal.

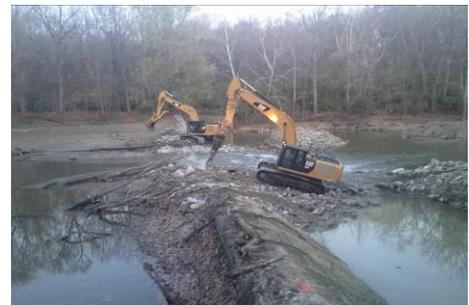
Excavators removing 300' wide dam.

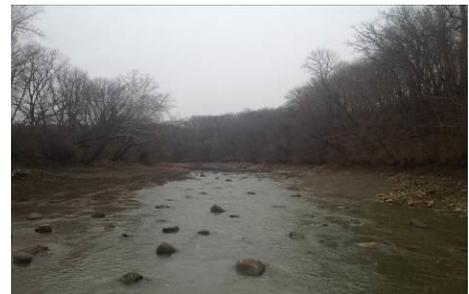
Large boulders and rock structures were placed in river for habitat.

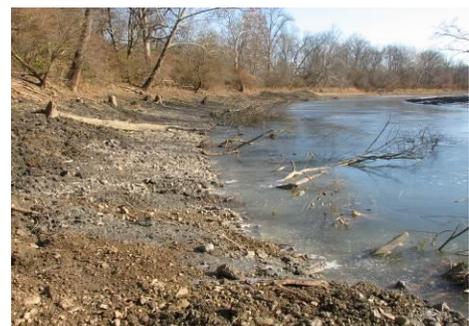
Woody debris and rock installed for aquatic habitat and bank protection.
